Tuesday 10 October 2017

# Smart Cushion 2 Year In-Service Summary Report

**Smart Cushion 2 Year In-Service Reset Data**

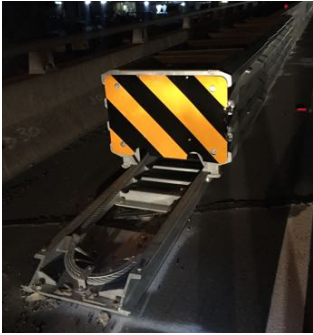
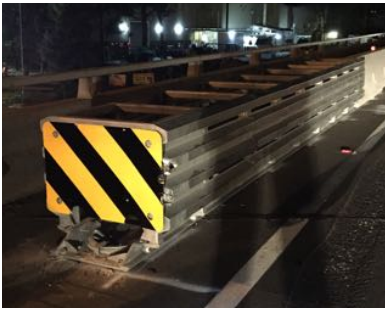
Details	Before Reset	After Reset
<p>Date of Reset: 28/7/15  Unit Number: 1  Severity: 30%  Repair Time: 70 mins  <u>Parts Used:</u>  Shear Pins</p>

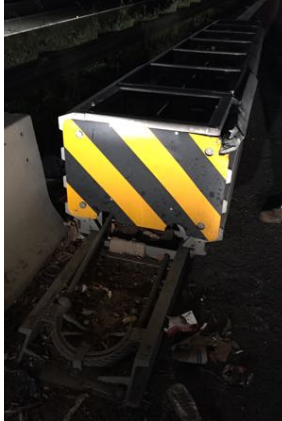
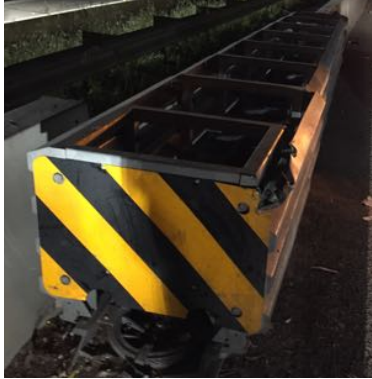
<p>Date of Reset: 6/10/15  Unit Number: 6  Severity: 15%  Repair Time: 46 mins  <u>Parts Used:</u>  Shear Pins</p>

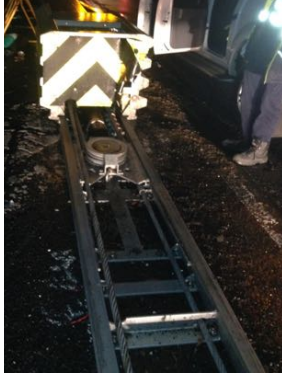
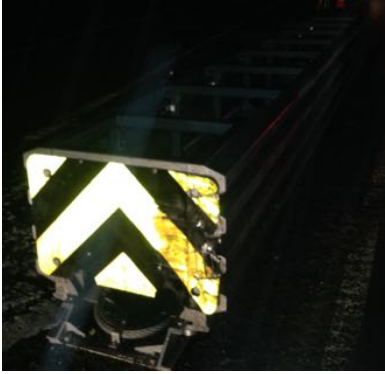
<p>Date of Reset: 4/11/15  Unit Number: 3  Severity: 100%  Repair Time: 85 mins  <u>Parts Used:</u>  Shear Pins</p>

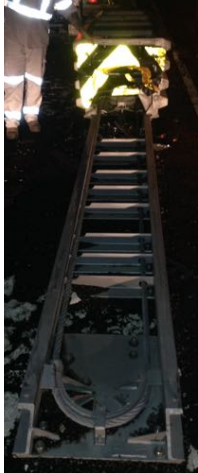
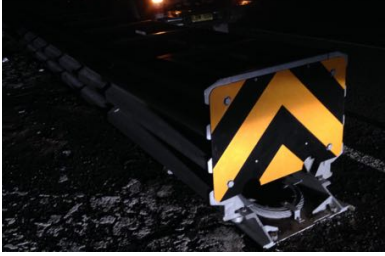
<p>Date of Reset: 12/11/15  Unit Number: 3  Severity: 80%  Repair Time: 65 mins  <u>Parts Used:</u>  Shear Pins  Delineator Panel</p>

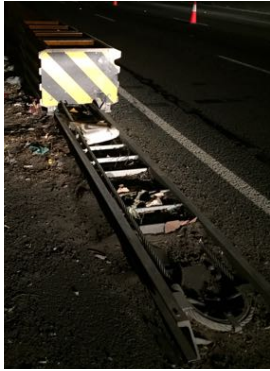
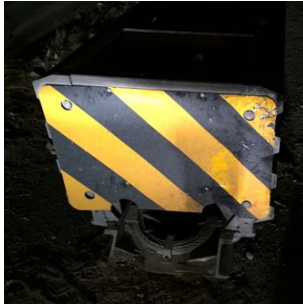
Details	Before Reset	After Reset
<p>Date of Reset: 4/5/16  Unit Number: 16  Severity: 60%  Repair Time: 42 mins  <u>Parts Used:</u>  Shear Pins</p>

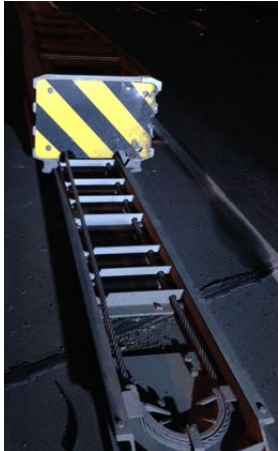
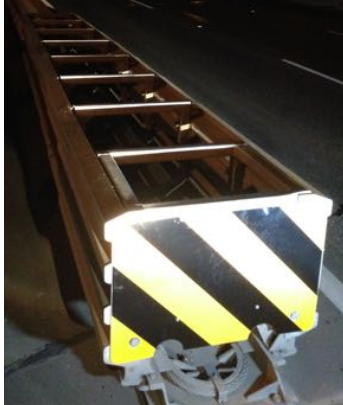
<p>Date of Reset: 16/6/16  Unit Number: 3  Severity: 40%  Repair Time: 95 mins  <u>Parts Used:</u>  Shear Pins  Delineator Panel</p>

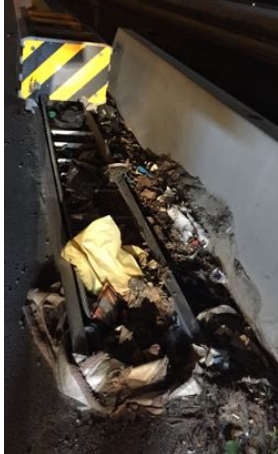
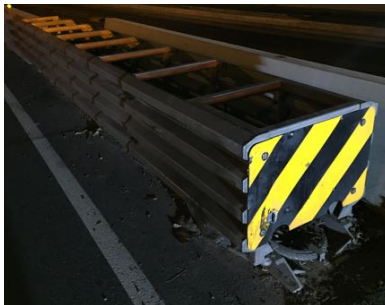
- During resets, Smart Cushions with up to 18 anchor pins missing or installed incorrectly were identified. Despite this, these Smart Cushions still functioned successfully. (Installation defects were due to untrained labour hire and minimal oversight by contractor. LBA's understanding is all defects were rectified within 24hrs of identification)
- During resets, it was noted that some Smart Cushions had been inundated with rubbish and debris. Despite this, these Smart cushions still functioned successfully. (Example photo supplied in sample photos, date of reset: 12/7/16)

<p>Date of Reset: 12/7/16  Unit Number: 19  Severity: 69%  Repair Time: 66 mins  <u>Parts Used:</u>  Shear Pins</p>

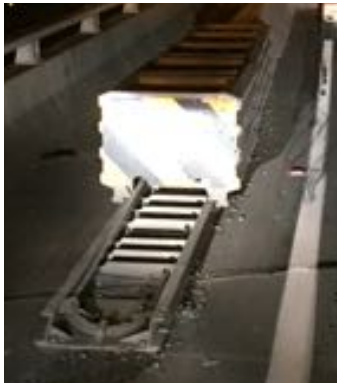
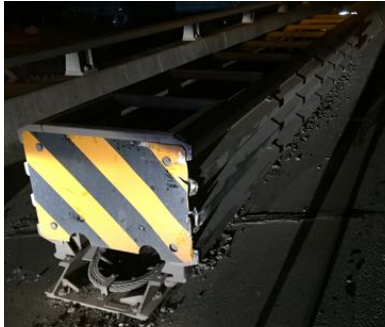
<p>Date of Reset: 10/8/16  Unit Number: 1  Severity: 40%  Repair Time: 36 mins  <u>Parts Used:</u>  Shear Pins</p>

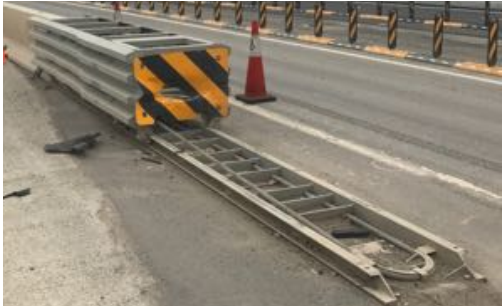
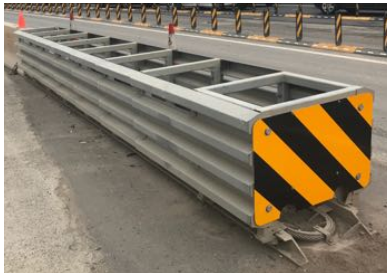
<p>Date of Reset: 25/3/17  Unit Number: 28  Severity: 58%  Repair Time: 37 mins  <u>Parts Used:</u>  Shear Pins  Delineator Panel</p>

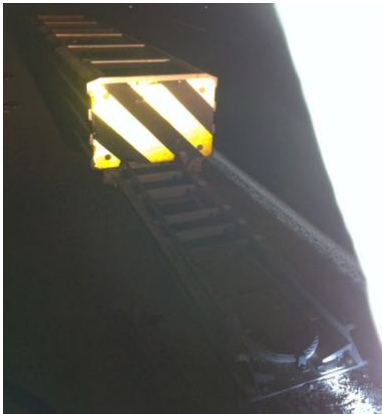
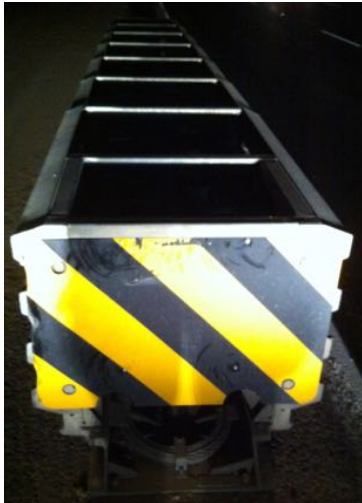
<p>Date of Reset: 7/5/17  Unit Number: 2  Severity: 51%  Repair Time: 36 mins  <u>Parts Used:</u>  Shear Pins</p>

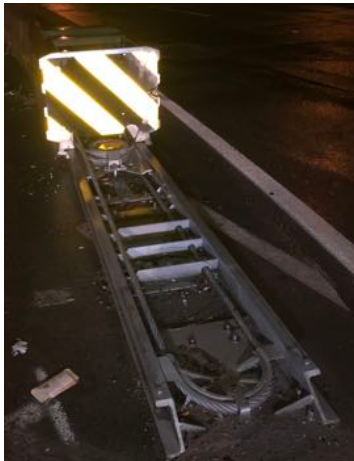
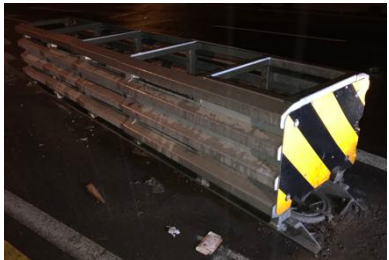
<p>Date of Reset: 7/6/17  Unit Number: 11  Severity: 86%  Repair Time: 54 mins  <u>Parts Used:</u>  Shear Pins</p>
